SANNUR CAVE – THE PROBLEMS OF OPENING A REMARKABLE CAVE IN EGYPT’S EASTERN DESERT

- Greg Middleton

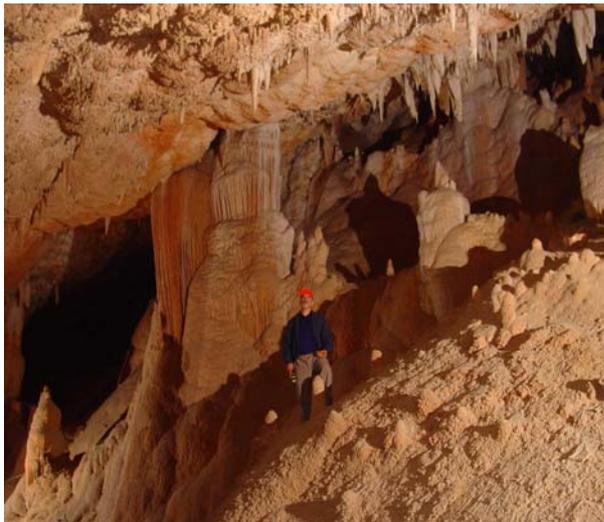
Fig. 2. The western gallery is chock full of massive stalagmites and columns in an impressive range of colours; the ceiling is a billowing mass of crystal growths punctuated by innumerable stalactites.

cave's speleothems are its great glory, They range from mammillaries and towering stalagmitic columns [Fig. 2] to glistening thickets of intricate crystalline "popcorn" and tiny glassy helictites. Stalactites vary from large tapered forms to soda straws. Some have secondary coatings of various thickness. Others are so glassy that they appear monocrystalline."

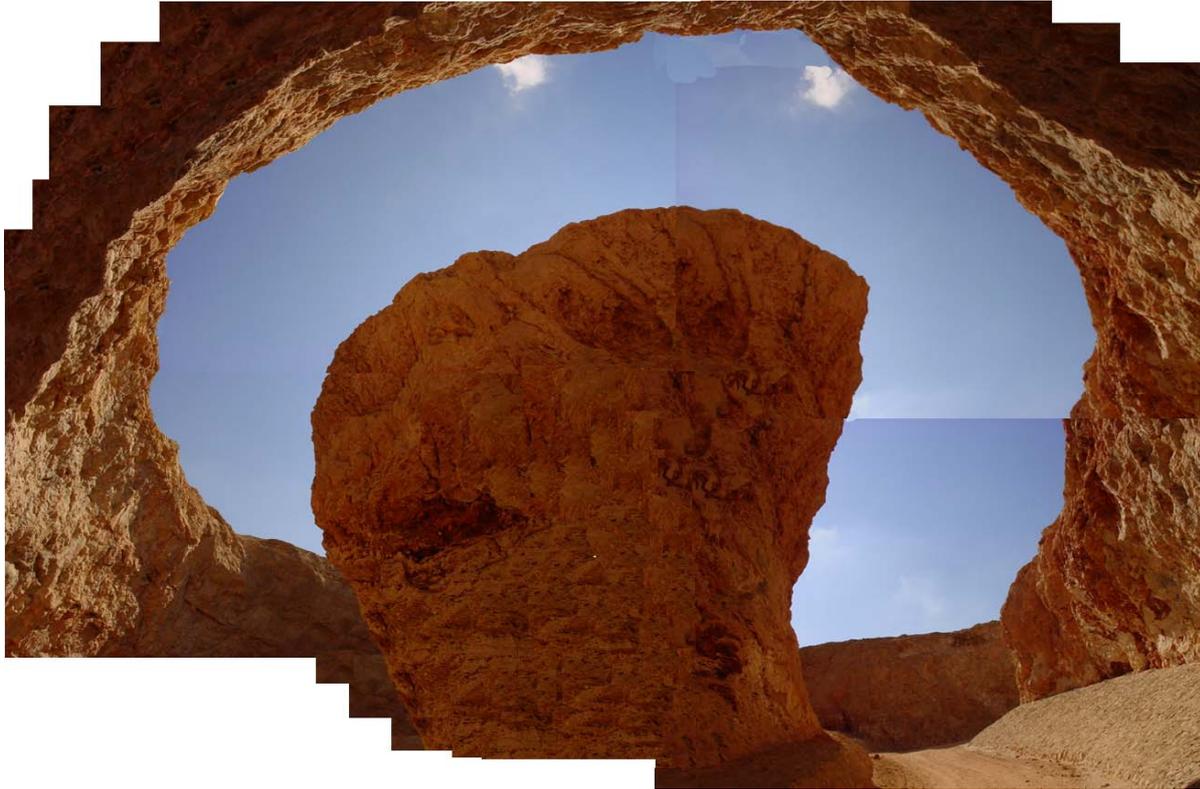
The major difficulty, however is posed by the very quarry which led to the cave's discovery. The hole in the earth is approximately 50 m in diameter (it is close to being round) and 50 m deep – with a near-circular column in the centre rising right to the original surface. Quarrying has clearly followed the most valuable stone with no regard for the resulting configuration. This has left massive overhangs around the perimeter (and on parts of the central column), extending out about 9 metres above where the cave entrance has broken through. It is difficult to imagine a more potentially dangerous structure. Fig. 4 is a composite made up of a number of photos in an effort to capture the view up from the quarry floor.

Fig. 4. Photo-montage of Sannur Quarry, looking up from the quarry floor. The faces overhang all around, extending out as far as 9 m in places. The access road comes from the right, leading down to the floor.

- 1) The removal of all overhanging walls, taking these back to at least vertical faces – and preferably a few degrees beyond. This would be very expensive and any such works would pose some threat to the cave. However, if funds allowed, it appears to be the safest long term measure to make the pit safe.

- 4) Rig a network of protective high-tensile steel cables and mesh, vertically and/or horizontally, to catch any falling rock. Halliday (2002) drew attention to the fact that “horizontal wire nets are used successfully at the bottom of world-famous Mococho Chasm in the Czech Republic” and this technique is also employed in front of the temple grotto on Mount Sanbang, Jeju Island, South Korea. In the case of Sannur such a structure would be very extensive, difficult to construct without further destabilising the quarry walls and not at all aesthetically satisfactory. If removal of the overhangs is not considered feasible, however, this technique might at least be considered for the large overhang above the actual cave entrance.
